Office of Structural Materials

Quality Assurance and Source Inspection

Contract #: 04-0120F4Cty: SF/ALA Rte: 80 PM: 13.2/13.9File #: 1.28**WELDING INSPECTION REPORT****Resident Engineer:** Casey, William**Address:** 333 Burma Road**City:** Oakland, CA 94607**Report No:** WIR-027879**Date Inspected:** 02-Jul-2012**Project Name:** SAS Superstructure**OSM Arrival Time:** 700**Prime Contractor:** American Bridge/Fluor Enterprises, a JV**OSM Departure Time:** 1930**Contractor:** American Bridge/Fluor Enterprises, a JV**Location:** Job Site**CWI Name:** As noted below**CWI Present:** Yes No**Inspected CWI report:** Yes No N/A**Rod Oven in Use:** Yes No N/A**Electrode to specification:** Yes No N/A**Weld Procedures Followed:** Yes No N/A**Qualified Welders:** Yes No N/A**Verified Joint Fit-up:** Yes No N/A**Approved Drawings:** Yes No N/A**Approved WPS:** Yes No N/A**Delayed / Cancelled:** Yes No N/A**Bridge No:** 34-0006**Component:** SAS OBG**Summary of Items Observed:**

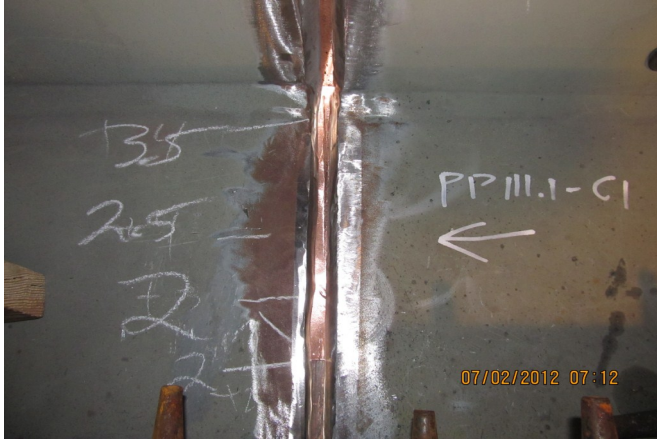
This QA Inspector made random observations of ABF/JV qualified welder Mike Jimenez performing Shielded Metal Arc Welding (SMAW) in the 1F flat position on 12E-E2.1 on the East Drop-In Panel on the exterior of the OBG. The welder was depositing metal forming seal passes on the edges of the joint at y+29,000mm to 31,000mm.

This QA Inspector observed QC Inspector Salvador Merino verify prior to the start of the fillet weld operation, that the minimum preheat temperature as per the approved WPS was established; and afterward's verified that the welding parameters (Amps) were in accordance with ABF-WPS-D1.5-F1200A. The welder was observed utilizing E7018-H4R electrodes and this QA Inspector verified that the electrodes were recently obtained from a baking oven. QC was observed measuring the inter-pass temperatures by employing an infra-red temperature gun as well as monitoring the welding and the parameters. It was noted that the welder was drawing amperage of 127 utilizing 3.2mm electrodes. On a subsequent observation, the welder was observed continuing work on the B-U2a Complete penetration Joint (CJP) and was employing the same routine to clean the passes. This QA Inspector made subsequent observations throughout the shift to monitor quality and noted that the work is in progress and appeared to be in general conformance with the contract specifications.

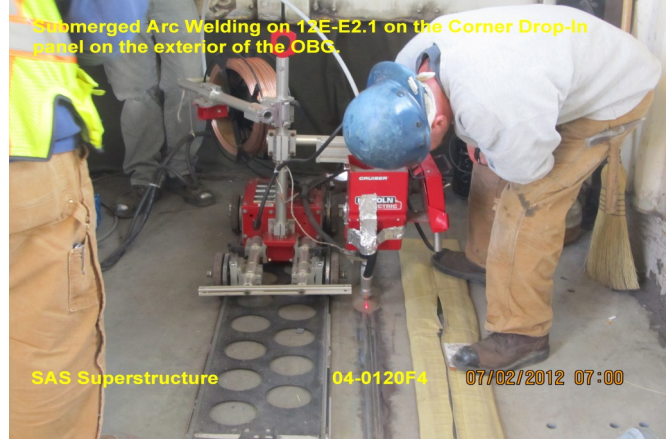
This QA Inspector randomly observed Submerged Arc Welding (SAW) of the Corner Drop-In Plate at 12E-E2.1 on the exterior of the OBG. This QA Inspector observed heat induction blankets to provide pre-heat for the single bevel joint and verified the temperature was the required minimum of 150° F. It was also noted that the remote oven for the ESAB EN 760 Flux was in the on position with the dial set at 250° F as ABF welding personnel employed a flux recycling vacuum hose to empty the feeder hopper of the SAW unit. This QA Inspector observed the removal of the electrode spool which was discarded and replaced with a new F7A2-EM12KH8 electrode spool. QC Inspector Salvador Merino measured the parameters for amperage, volts, travel speed and the heat input as ABF welder Todd Jackson #4639 adjusted the controls on the Lincoln track mounted wire feeder. Upon approval for conformity with WPS-D1.5-4042B-1, the welder commenced welding operations on the joint in the 1G flat position. On a subsequent observation, this QA Inspector observed ABF welding personnel recycle the flux utilizing a vacuum hose and cleaning the edge of the work with a chipping hammer between passes. The welder was observed adjusting the path of the feeder prior to each consecutive pass during the ongoing process and inspected each completed pass for indications and workmanship. QC was present to monitor the welding and the parameters so they remain within the requirements of the WPS. This QA Inspector made subsequent observations throughout the shift to monitor quality and noted that the work was in process and appeared to be in general conformance with the contract specifications.
